Communication towers, lights, and birds: successful methods of reducing the frequency of avian collisions

Joelle Gehring,^{1,4} Paul Kerlinger,² and Albert M. Manville II³

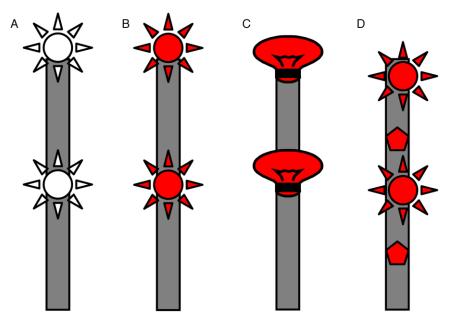
FIG. 2. Four different communication tower obstruction lighting systems were installed on the Michigan Public Safety Communication System (MPSCS) towers. All lighting systems were 116–146 m above ground level. (A) Three guyed and three unguyed towers with white strobes (L-865) at the top and mid levels; no non-flashing (L-810) incandescent lights. (B) Three guyed and three unguyed towers with red strobes (L-864) at the top and mid levels; no non-flashing (L-810) incandescent lights. (C) Three guyed and three unguyed towers with red strobes (L-864), incandescent lights at the top and mid levels; no non-flashing (L-810) incandescent lights. (C) Three guyed towers with red strobes (L-864), incandescent lights at the top and mid levels; with red, non-flashing (L-810), incandescent lights at three-quarters and one-third the height of the tower (current/status quo lighting system for many communication towers, including MPSCS towers). The areas under these towers were simultaneously and systematically searched for bird carcasses during 20 consecutive mornings surrounding the peak of songbird migration in the spring and fall of 2005.

We randomly assigned nighttime lighting systems to MPSCS towers 116–146 m AGL. Given that the FAA currently only allows towers to be lit at night with white strobes (L-865) or red, flashing lights (L-864) combined with red, non-flashing lights (L-810), we were required to request marking and lighting variances from the FAA for those towers selected for change (see Plate 1). After receiving marking and lighting variances, personnel at the MPSCS changed the tower lights to study specifications. The following lighting systems were each installed at three guyed towers and three unguyed towers: (1) white strobes (at the top and at one-half the height of the tower); (2) red, strobe-like lights (at the top and at onehalf the height of the tower); and (3) red, flashing, incandescent lights (at the top and at one-half the height of the tower) (Fig. 2). Three guyed towers were maintained with the status quo red, strobe-like lights (at the top and at one-half the height of the tower) combined with red, non-flashing lights (L-810) at onethird and three-quarters the height of the tower (i.e., status quo; Fig. 2). The three guyed towers >305 m AGL had standard, red, flashing, incandescent lights (L-864) combined with non-flashing, incandescent lights (L-810).

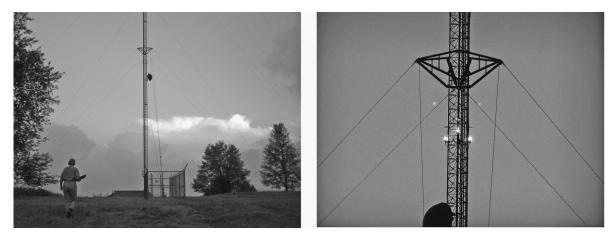
PLATE 1. In May and September 2003–2005, technicians seached under Michigan, USA, communcation towers for avian carcasses. Migratory birds collide with these structures and their supporting guy wires during periods of attraction to the nighttime lighting systems. Numbers of avian carcasses were compared among towers with different Federal Aviation Administration lighting systems. Photo credits: J. Gehring.
